# St. Pancras, Euston Rd, London: A Case Study in Matching Historic Brickwork

ELENI MAKRI

*The Station and the former Midland Grand Hotel at St. Pancras in London have been at the centre of a major construction and infrastructure programme. This included the insertion of a new Western Ticket Hall for London Underground underneath the raised forecourt of the grade I listed building. The author was appointed as specialist advisor to London Underground's project team on the historic brickwork associated with the new ticket hall. Detailed investigation and analysis were undertaken of the bricks, mortar and pointing as used by George Gilbert Scott in the original Victorian work. This guided the development of specific manufacturing techniques to achieve the required appearance of new brickwork with very fine brickwork joints. The new methodology was used on the repair work to the raised forecourt in front of the former Hotel, in particular the reconstruction work on the elevation facing King's Cross Station.*

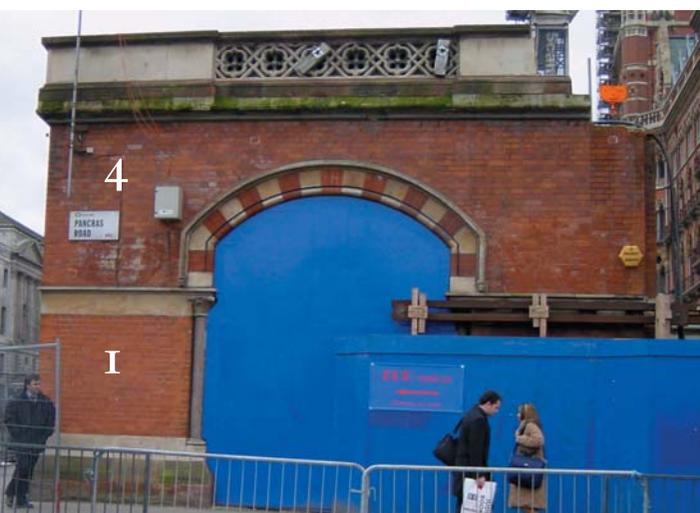
Early photographs show St Pancras shortly after its completion in c. 1880. The two middle arches of the brickwork associated with the elevated front onto Pancras Road (Fig. 2) were replaced in the early twentieth century with a single flight of stairs (Figs. 3–4). These stairs were taken down as part of the London Underground construction of the Western Ticket Hall, as was one of the remaining original arches of the forecourt wall onto Pancras Road where it adjoins the clock tower (Fig. 5). The intention had been for the arch and stairs to be rebuilt once the extension was complete.

Fig. 5. Pancras Road façade of the elevated forecourt following the London Underground Limited demolition – Areas 1 and 4 of original brickwork.

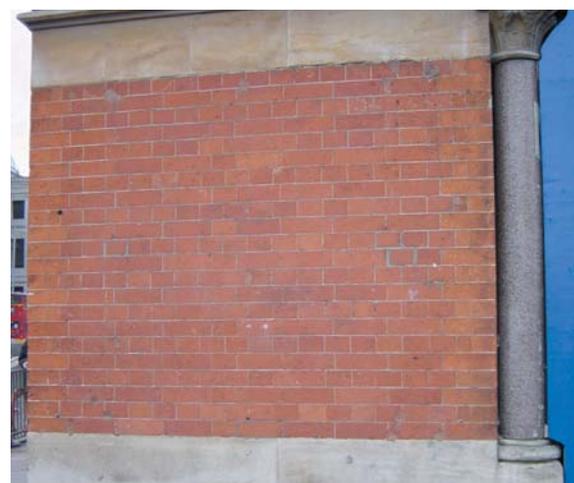
**Area 1** (Figs. 5–7): the single-storey elevated front terrace (forecourt) of St Pancras retains undisturbed areas of original brickwork, with Area 1 onto Euston Rd being one of these. Characteristic here are the fine

Fig. 6–7. Area 1: overview and detail of original brickwork with fine joints and original Gripper bricks on the elevated forecourt of Pancras Road; the joints now show and off-white mortar.

joints, 4mm wide or less in the horizontal with the vertical joints being overall even finer than the horizontal. Their sizes were confirmed and recorded by measured survey. The mortar mix is off-white with pronounced aggregates and an incised line to the horizontal. The brickwork is laid in English bond, as is the case throughout the building. Bricks manufactured by Gripper<sup>1</sup> were recovered from the adjoining demolished area and this is consistent with the records of both the preference of the architect and the earlier construction date (Stage 1) of this part of the building.

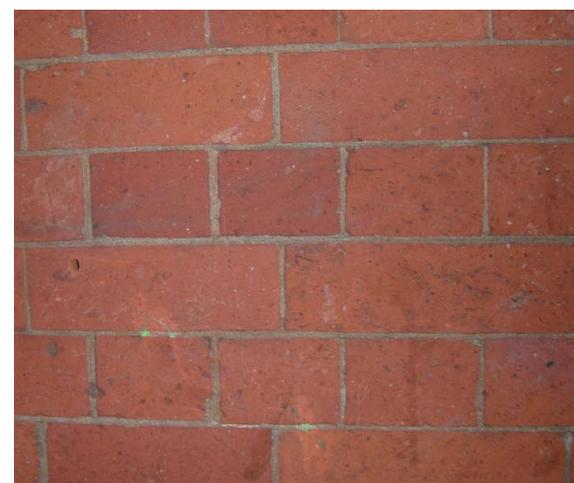
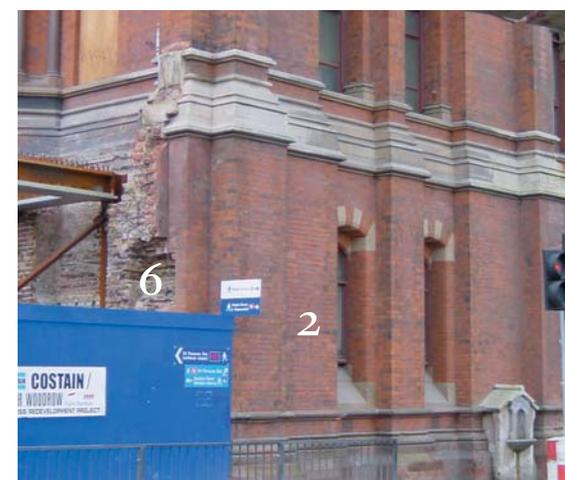
**Area 2** (Figs. 8–9): the façade of the Clock Tower onto Pancras Road adjoining the elevated terrace displays similarly sized joints and mortar mix which however here appear to have been coated with a blackish material. When first seen, this coating may be mistaken for dirt from atmospheric pollution. Interestingly, further observations of brickwork elsewhere on the main façade of the building provide strong evidence to suggest that this is a remnant of the original joint finish.

Fig. 8–9. Area 2: overview and detail of original brickwork with fine joints to the Clock Tower, Pancras Road. The blackish coating to the white mortar is now believed to have been the original joint finish.

means of (thin) tuck-pointing in black. This confirms that the dark coating on the façade to Pancras Road is the original joint finish, rather than the result of atmospheric pollution.

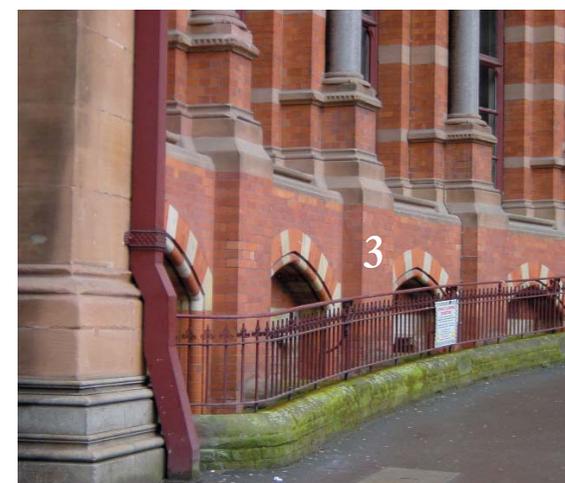
**Area 3** (Figs. 10–11): the curved façade of the west wing, onto Euston Road, displays areas of original red mortar joints which are ‘tuck-pointed’ black. Importantly, the red joints here are wider than those described earlier and of the same colour as the bricks. Finished flat, they provide a homogenous red background of bricks and red joints, which is then broken down to regular English bond coursing by

Fig. 10–11. Area 3: overview and detail of the curved elevation onto Euston Road. Original brickwork showing black tuck pointing over red stopping mortar, confirming the black joint finish as the original finish throughout the building.

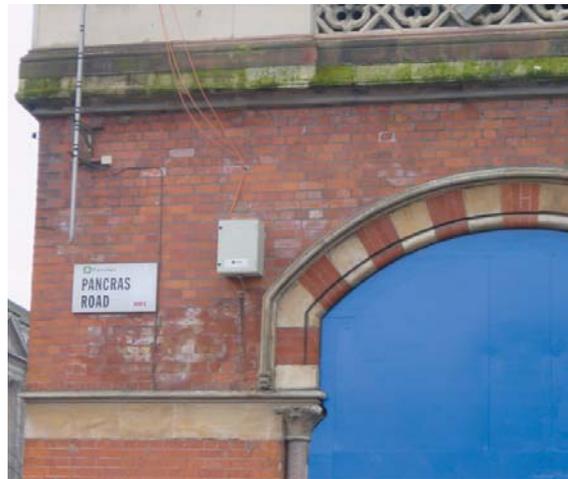
Fig. 12. Area 4: earlier repairs to original brickwork, incorporating new bricks above Area 1 brickwork on the elevated forecourt, Pancras Road.

**Area 4** (Fig. 12): this is located directly above Area 1. Seen from a distance, Area 4 appears to be of a different palette to Area 1. There are three main reasons for this:

Firstly, the new bricks used in the 1990s repairs are of a different colour and surface texture to the

original, because the originals have lost their fired faces. (Interestingly, the 1990s brick emerges as an excellent match when compared with the protected faces of an original.)

Secondly, the 1990s joints are greyish in colour with a flat finish. As such they match neither the colour nor the finish of the original work, as identified in Areas 1, 2 and 3 above, although seen in isolation the flush joint finish has the appearance of considered conservation work.

Thirdly, the 1990s joints (horizontal and vertical) are approximately 6–7mm wide and therefore significantly wider than the 4mm horizontal joints of the original brickwork. An important implication of this is that the height of the new coursing is greater than the original and the resulting misfit is evident where repairs and original work adjoin each other, detracting from the quality of the original.

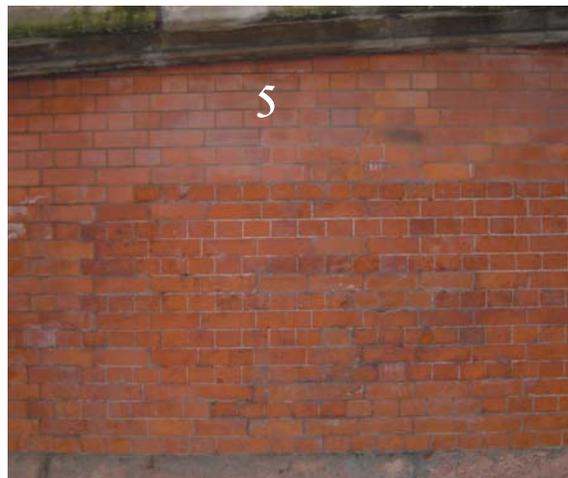
Fig. 13. Area 5: The elevated forecourt, Euston Road: overview of original brickwork and 1990s repairs incorporating a new Ibstock brick (Tucker) and a 7mm wide greyish joint finish.

**Area 5** (Figs. 13–14): The visual implications of the 1990s repairs on the original brickwork and in particular the misfit of the new to the original coursing and finishes are also evident in the Euston Road façade of the elevated terrace.

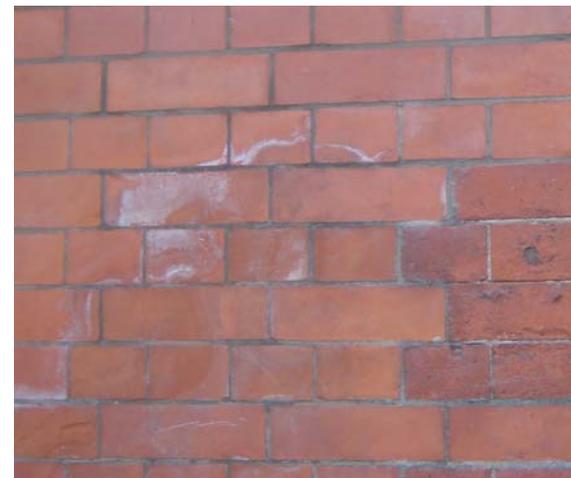
Fig. 14. Area 5: detail showing the misfit between original coursing and the 1990s repairs.

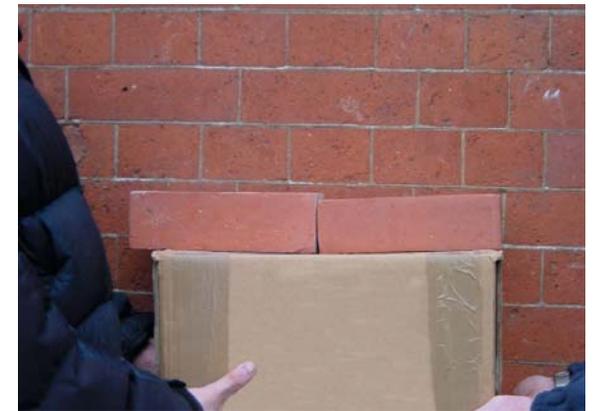
Fig. 15. An original Gripper brick from the demolition and an Ibstock metric 're-pressed' brick are both photographed in front of Area 1 of the original brickwork onto Pancras Road.

By the time the author was instructed, several brick manufacturers had already produced a number of new bricks. Following detailed consultations with the manufacturers, samples of the most promising bricks were now taken to site. Combined with reclaimed examples of the original Gripper bricks, they were photographed against the original wall, in the actual light conditions that a chosen brick would eventually be seen. This exercise confirmed a 're-pressed' brick made by Ibstock as the best candidate (Fig. 15).

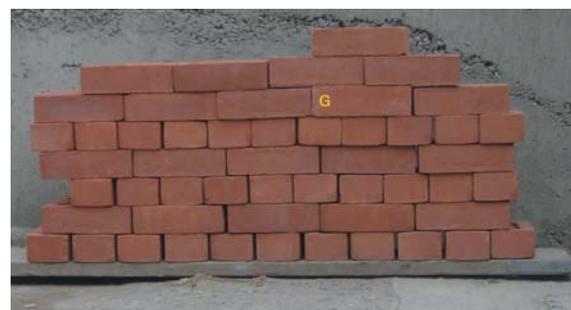
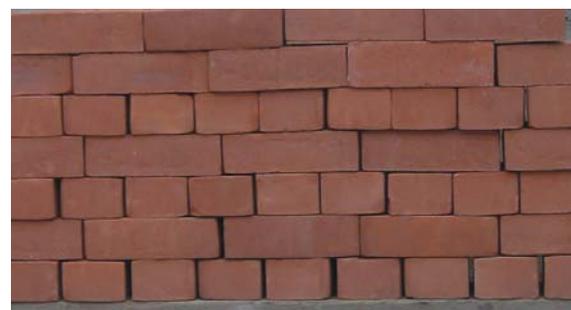
A dry brickwork sample was constructed on the request of English Heritage as the final test prior to their approval of the proposals using a second batch of ‘re-pressed’ brick samples (Figs. 16–17). This revealed the nature of the ‘re-pressed’ brick as a stretcher brick, because the re-pressing treatment created a textured surface on only one side. This meant that banding

Fig. 16–17. Dry brickwork sample in Ibstock metric ‘re-pressed’ bricks (2nd batch) incorporating one Gripper brick (marked G).

could occur in the brickwork between stretcher and header courses, which would have not been appropriate. In order to avoid this, the specification agreed with Ibstock included the possibility for mixing ‘snapped headers’ (stretcher bricks cut in half) in the header course.

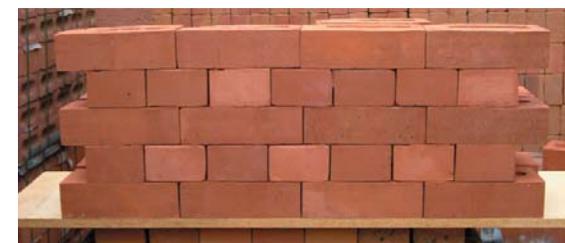
Fig. 18. Sample dry brickwork of the imperial size ‘re-pressed’ Ibstock brick, cut on three sides. The necessary regular fine joint was still not achieved.

Unfortunately, the mass manufacturing of the approved brick proved much more difficult than Ibstock had anticipated and brick tolerances remained too high (Fig.18). As a result a five-cut approach was finally employed to achieve coordination that would match both original brick and joint sizing. In the 5-cut approach all sides of each brick with the exception of the exposed facing side were cut so that the remaining unevenness was all removed. Corner bricks with two exposed sides were also procured, which only had 4-cut surfaces, so that cut surfaces (which had through this process lost their fired skins) would not be exposed to weathering.

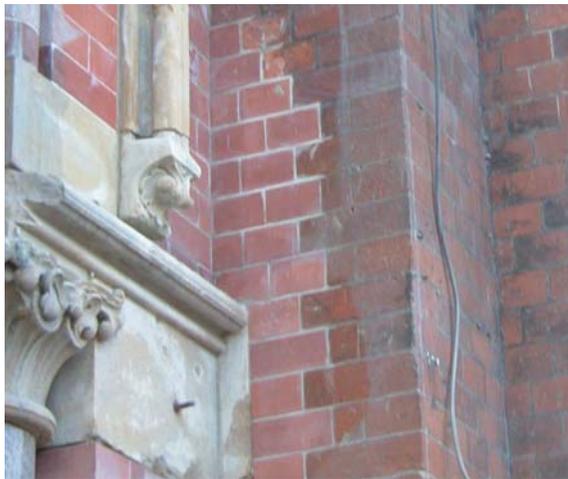
Fig.20.Reconstruction detail: alignment of new and old brickwork by the Clock Tower.

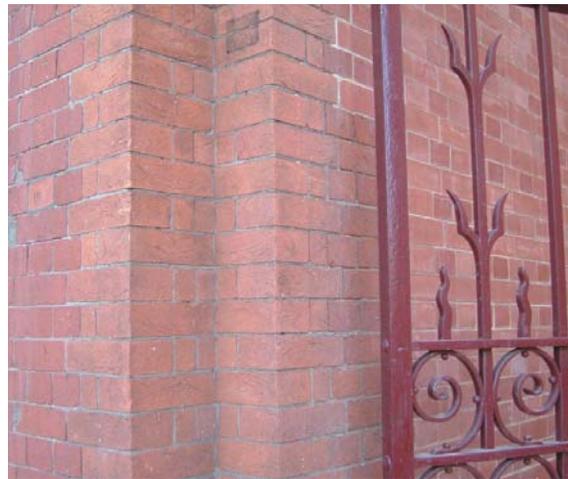
Fig.22.Reconstruction detail: original brickwork (left); early twentieth-century quoins to stairs return in Charnwood bricks; and reconstructed brickwork (behind reclaimed gates).

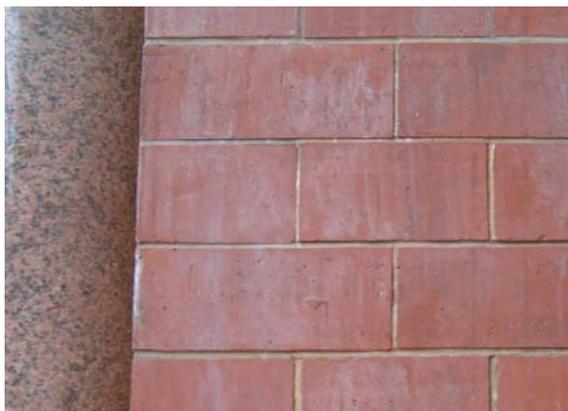
Fig.21.Reconstruction detail: new brickwork and reclaimed granite column.

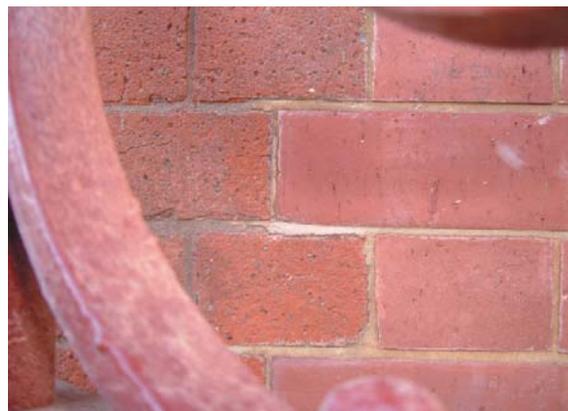
Fig.23.Detail of above showing early twentieth-century Charnwood quoins (left) and new brickwork (right) on stairs return.

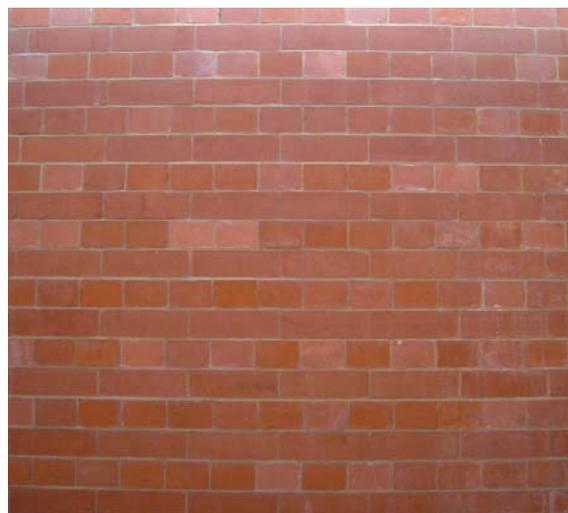
Fig.24.Reconstructed brickwork detail: compare with fig. 6 and 7.
