# IRON RAILINGS

## A CONSERVATION CASE STUDY

ELENI MAKRI

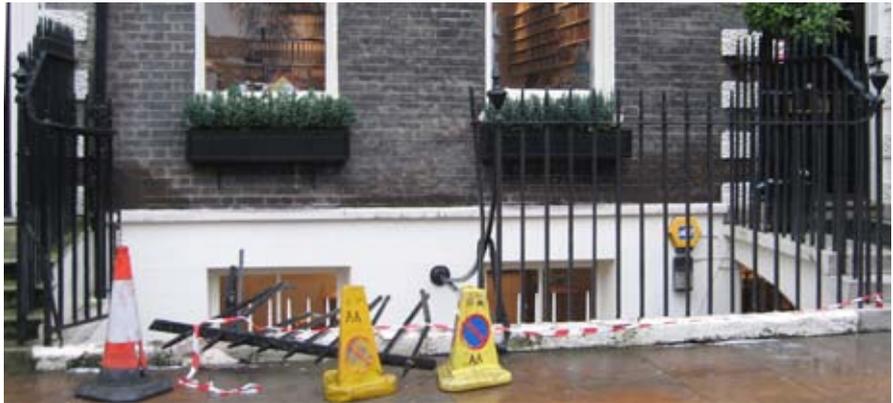
The impact of the car, as well as severely damaging one of the panels, had caused movement to the whole enclosure, including the gate standard and pivot. The wrought iron balusters in the damaged panel were buckled and dislodged, and the stone plinth sockets had been broken as a result. The cast iron coping remained attached to the collapsed balusters as the coping itself broke into two pieces, consistent with the brittleness of cast iron.

*The damaged railings following the impact of a car in snowy conditions*

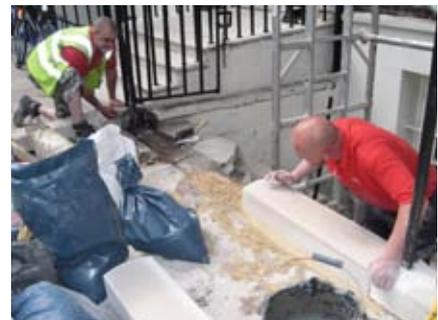
*Partial replacement of the Portland stone plinth*

mortar repairs to the Portland stone plinth section which had supported the collapsed metalwork because the original sockets in the plinth were too badly damaged. It was therefore decided that this part of the plinth would be replaced with new matching Portland stone and a workshop drawing was accordingly produced by the mason and checked on site.

- 3 Portland stone stage 2: the relevant stone plinth sections were removed and the new

stone was bedded in on a sand and non-hydraulic lime mix with the minimum amount of water.

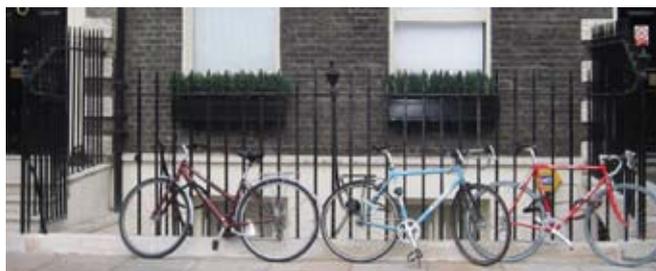
The completed repairs
