# St. Pancras, Euston Rd, London: A Case Study in Matching Historic Brickwork

ELENI MAKRI

*The Station and the former Midland Grand Hotel at St. Pancras in London have been at the centre of a major construction and infrastructure programme. This included the insertion of a new Western Ticket Hall for London Underground underneath the raised forecourt of the grade I listed building. The author was appointed as specialist advisor to London Underground's project team on the historic brickwork associated with the new ticket hall. Detailed investigation and analysis were undertaken of the bricks, mortar and pointing as used by George Gilbert Scott in the original Victorian work. This guided the development of specific manufacturing techniques to achieve the required appearance of new brickwork with very fine brickwork joints. The new methodology was used on the repair work to the raised forecourt in front of the former Hotel, in particular the reconstruction work on the elevation facing King's Cross Station.*

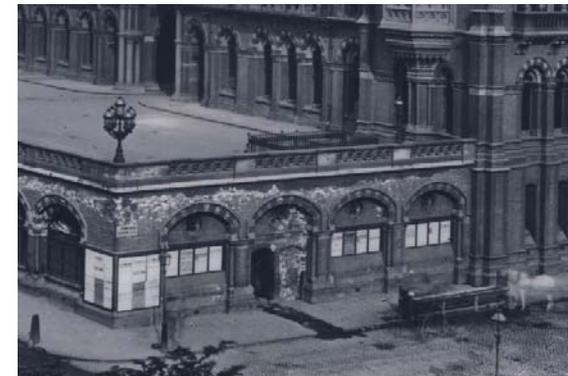
Fig.2. Part of the Pancras Road façade of the elevated forecourt shortly after its completion, c1880. (Reproduced by the permission of English Heritage, NMR)

Early photographs show St Pancras shortly after its completion in c. 1880. The two middle arches of the brickwork associated with the elevated front onto Pancras Road (Fig. 2) were replaced in the early twentieth century with a single flight of stairs (Figs. 3–4). These stairs were taken down as part of the London Underground construction of the Western Ticket Hall, as was one of the remaining original arches of the forecourt wall onto Pancras Road where it adjoins the clock tower (Fig. 5). The intention had been for the arch and stairs to be rebuilt once the extension was complete.

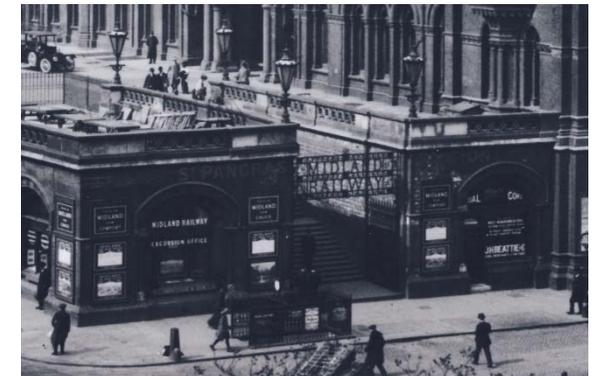
Fig.3. Alterations to the Pancras Road façade of the elevated forecourt at the beginning of the twentieth century. (Reproduced by the permission of English Heritage, NMR)

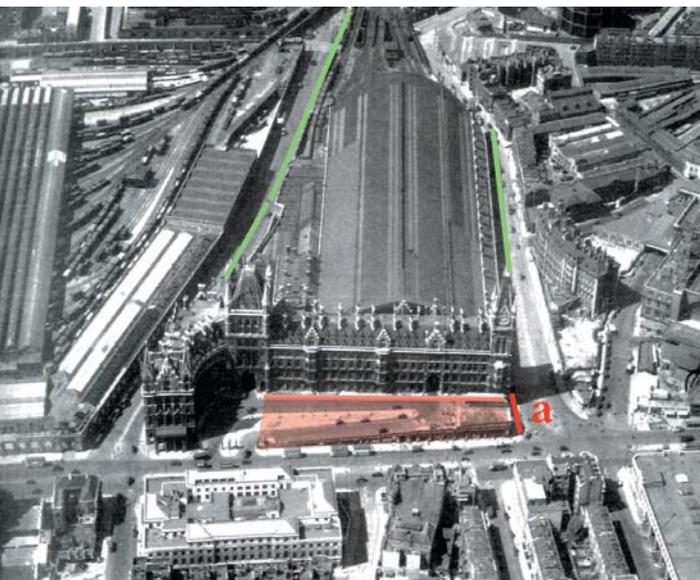
Two main projects were undertaken which affected the historic brickwork and these are both shown in the annotated aerial view of St Pancras (Fig. 1): London Underground Limited's (LUL) project to insert the new Western Ticket Hall of King's Cross under the raised forecourt of St Pancras, and the Channel Tunnel Rail Link (CTRL) project. Both projects were undertaken using the powers provided by the CTRL Act 1996. The author's professional involvement as a historic buildings specialist and this paper are exclusively on the London Underground project to conserve the forecourt façade.

Fig.1. An aerial view of St Pancras showing the areas in which brickwork is affected: green – the CTRL project; red – the London Underground Limited project; (a) the London Underground demolition. (image but not annotations reproduced from Jack Simmons)

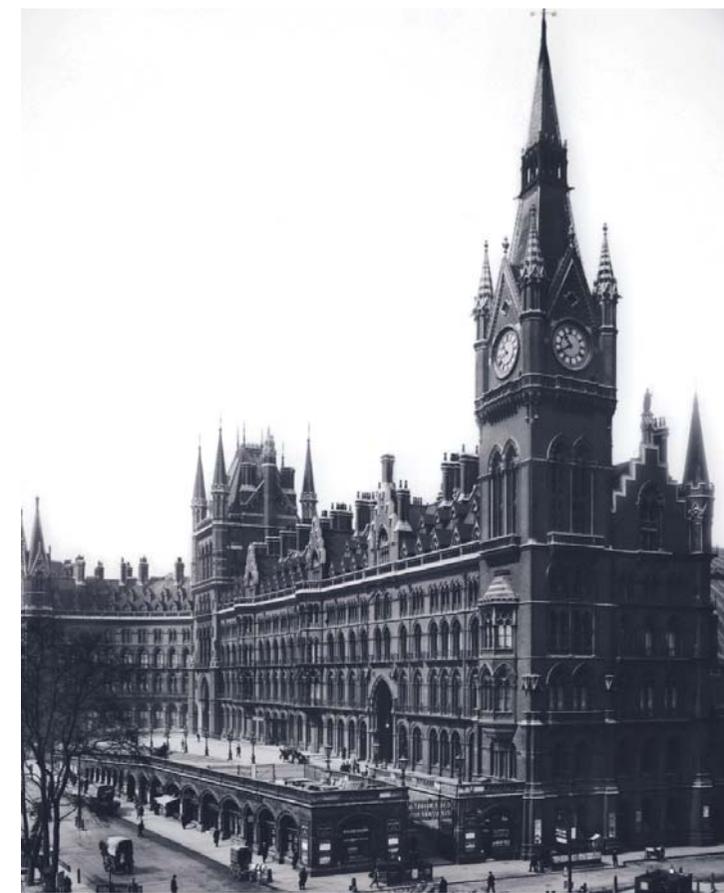
Fig.4. The Pancras Road façade prior to the London Underground limited demolition. (Reproduced by the permission of English Heritage, NMR)

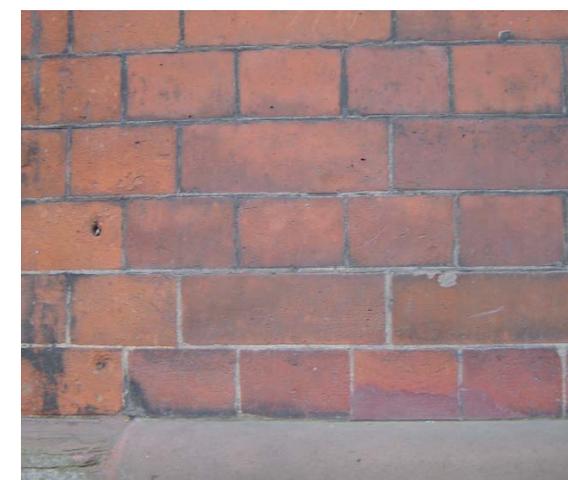
Fig. 12. Area 4: earlier repairs to original brickwork, incorporating new bricks above Area 1 brickwork on the elevated forecourt, Pancras Road.

The underlying philosophy of the previous repair works of the 1990s, and the effect it had on the appearance of the original, can be studied in the repairs evident on the brickwork of the elevated forecourt both on Pancras and Euston Road. Areas 4 and 5 respectively are examined below.

Firstly, the new bricks used in the 1990s repairs are of a different colour and surface texture to the

Thirdly, the 1990s joints (horizontal and vertical) are approximately 6–7mm wide and therefore significantly wider than the 4mm horizontal joints of the original brickwork. An important implication of this is that the height of the new coursing is greater than the original and the resulting misfit is evident where repairs and original work adjoin each other, detracting from the quality of the original.
